Strong growth in the number of solar panels with defects in 2020

Invisible damage to solar panels with major consequences

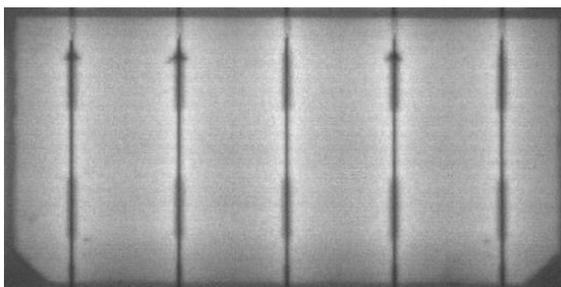
The most common defects are cracks on the bus bars, usually at the start of the bus bar. We have found a range of these cases, from tiny dots to cracks running through the entire cell. These cracks form during the soldering process and can, even with normal careful handling, develop into cracks across the entire length of the cell. When these cracks are located on the outside of the cell, i.e. outside the outer bus bar, they can isolate parts of the cell from the bus bar. At these places, the flow of energy slows down and hot spots can arise. Hot spots cause higher energy resistance and therefore a reduced yield. When the cracks are located between the bus bars, they are assessed as non-critical; when they are located on the outside of the cell, the crack can be assessed as critical, with the result that the panel is assessed as class B. When a panel has non-critical cracks in more than 10% of the cells, the module is assessed as class B.

Figure 1 Small V-shaped cracks

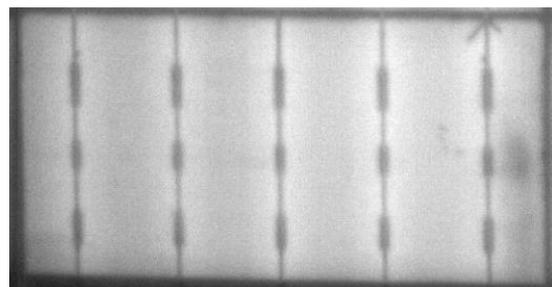
Figure 2 A V-shaped crack with a branch to the outside of the cell

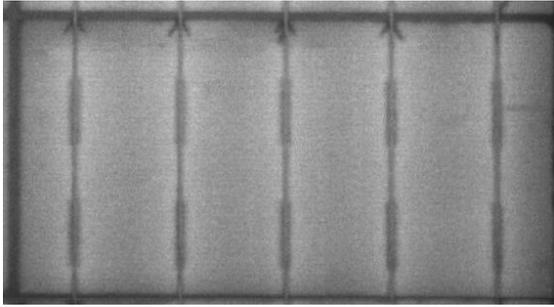
Figure 3 A cell with V-shaped cracks on 4 of the 5 bus bars expanded

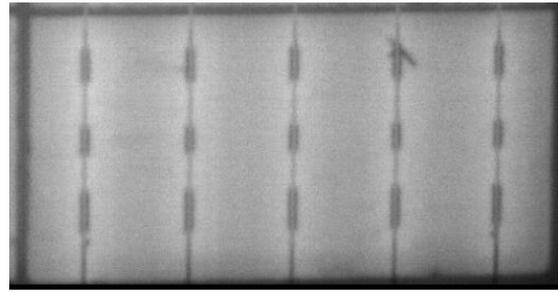
Figure 4 A crack that has not yet expanded

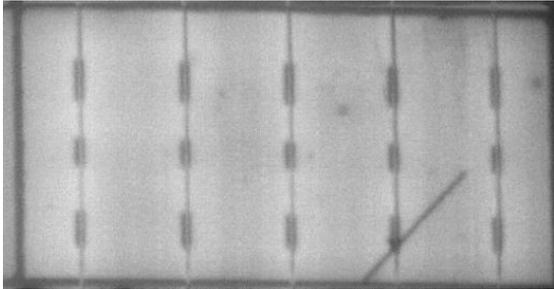
Figure 5 An example where a small crack has grown into a larger crack

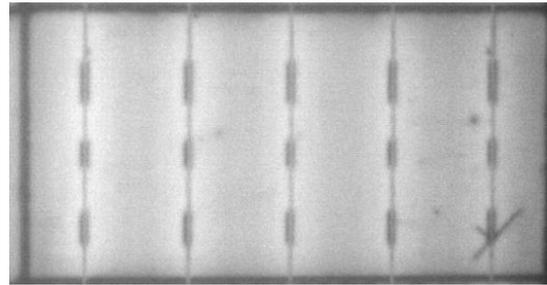
Figure 6 A crack on the outside of the cell, causing the crack to isolate part of the cell

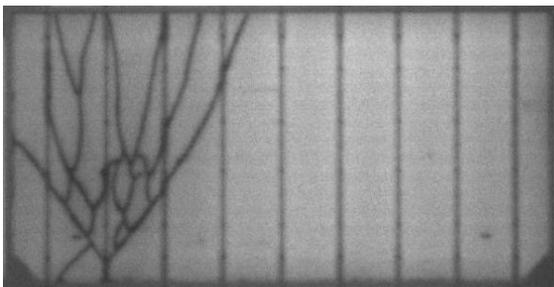
In addition to the small cracks that grow into larger cracks, we have also found damage that was serious from the very beginning. The examples shown here are all from panels right out of the box. These cracks are assessed as critical or very critical and lead to an assessment of the panel as class B or C. This damage has almost always occurred during transport or handling during the long journey from factory to project.

Figure 7 Critical damage to a cell

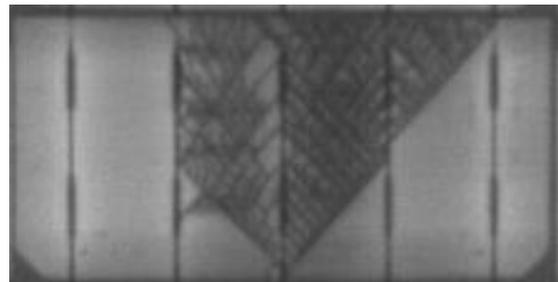
Figure 8 Highly critical damage

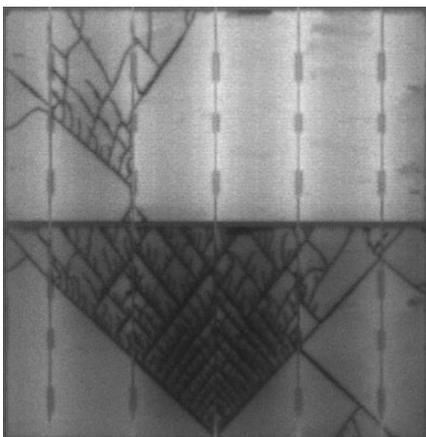
Figure 9 Highly critical damage

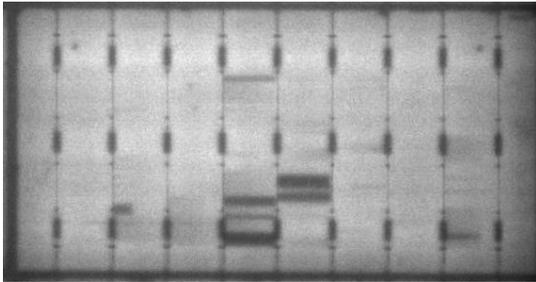
These fingers are printed on the cell material by means of a screen printing process. In the example below, some of these fingers are improperly printed; these become visible as dark horizontal lines between the bus bars.

Figure 10 Defective "fingers"

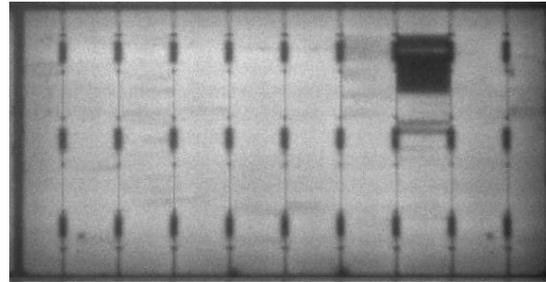
Figure 11 Defective "fingers". These cause hot spots that influence the yield from the cell and the panel

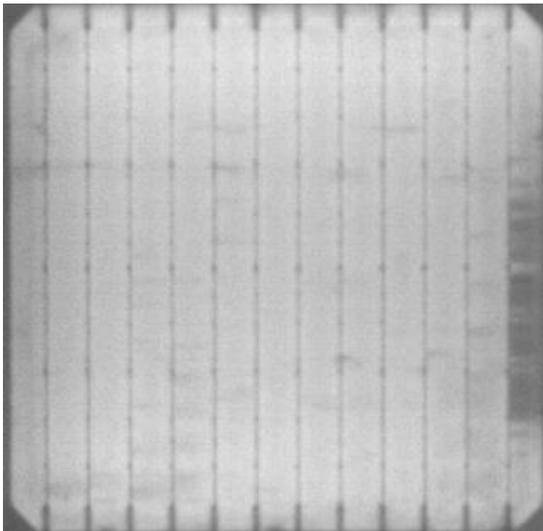
Figure 12 Improper soldering

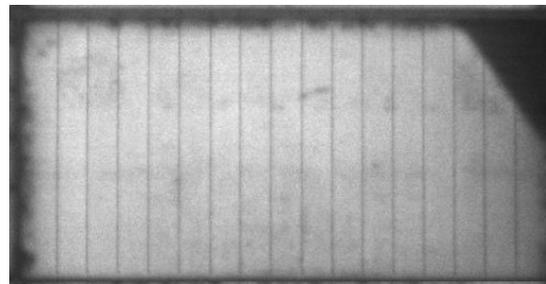
Figure 13 An example of a cell in which part of the corner has been broken off

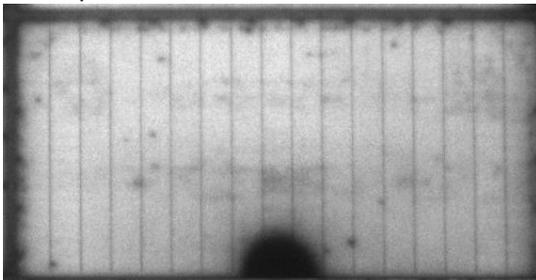
Figure 14 Dark areas of the cell produce less or no power and can cause hot spots

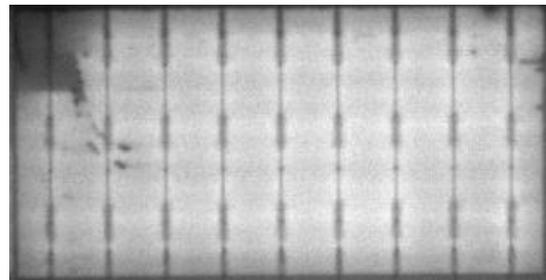
Figure 15 Contamination in the cell material

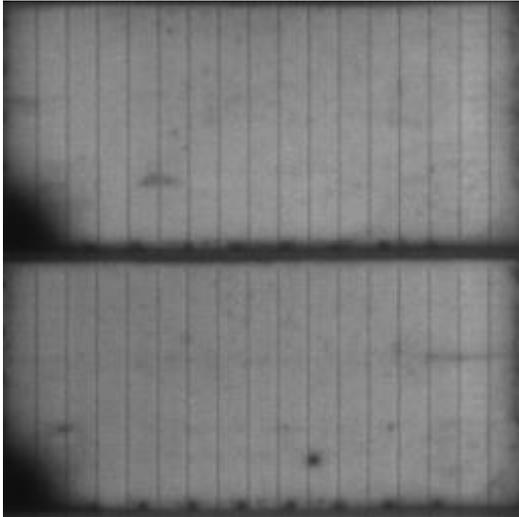
Figure 16 Low-quality soldering on contiguous cells

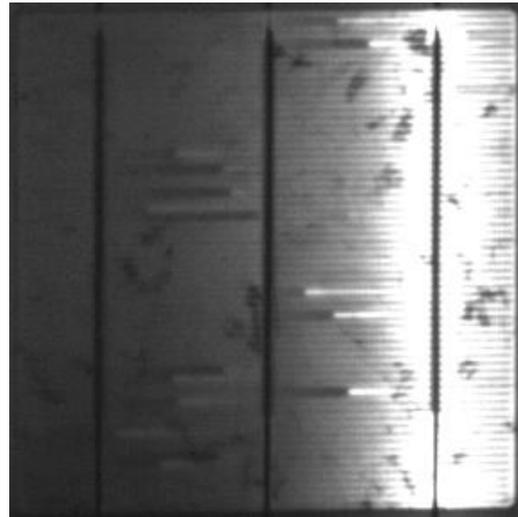
Figure 17 Poor soldering

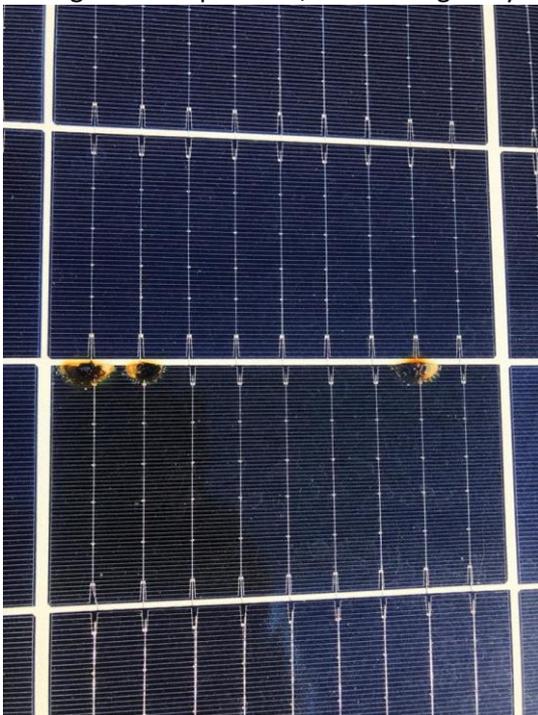
Figure 18 Melted areas due to short circuit

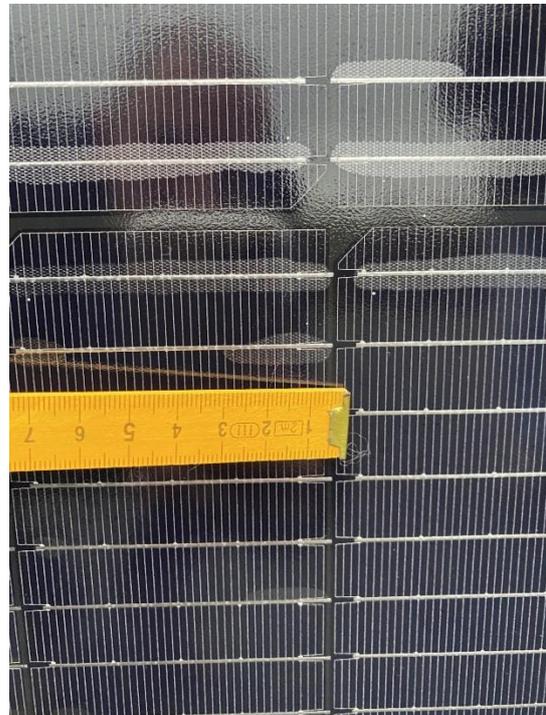
Figure 19 Delamination

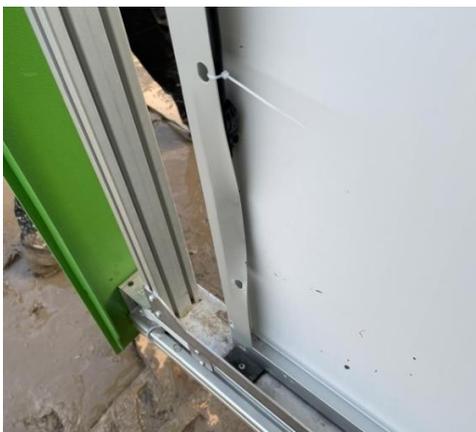
Figure 20 Transport damage

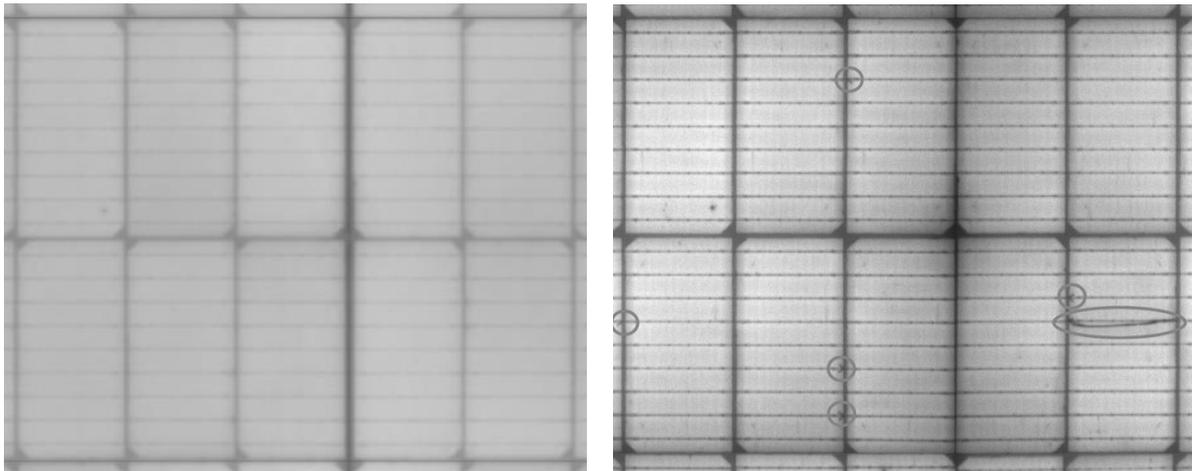
There are several reasons why the defects shown end up on the market. Firstly, manufacturers often apply less stringent quality criteria than we expect. Secondly, the EL images produced in the factory are generally of lower quality than the images produced by SolarTester. Thirdly, the factory images are created during and immediately after the production process, while SolarTester creates images when a large part of (or the entire) logistics process has been completed. To illustrate this, below are 2 excerpts of EL images. The first image was made in the factory. The second picture shows the image made by SolarTester. The small V-shaped cracks are not visible on the factory image; these cracks are clearly visible on the SolarTester image. One of the cracks has even grown into a crack that runs through the entire cell.
